| 2700-FM-AQ0023 Rev. 1/2008 | | <b>INSPECTION REPORT</b> | | Commonwealth of Pennsylvania<br>Department of Environmental Protection<br>Air Quality Program | |
| Date(s) of Inspection:<br><b>1/3/2023</b> | TV <input type="checkbox"/> PA <input type="checkbox"/><br>SM <input type="checkbox"/> GP <input checked="" type="checkbox"/><br>NM <input type="checkbox"/> MEGA <input type="checkbox"/> | Permit #(s):<br><b>63-01001</b> | Expiration Date:<br><b>8/7/2023</b> | Case #:<br><b>63-01001</b> | PF ID #:<br><b>805136</b> |
| Company Name:<br><b>ETC Northeast Pipeline LLC</b> | | Municipality:<br><b>Smith Twp</b> | | County:<br><b>Washington</b> | |
| Plant Name:<br><b>Revolution Cryo</b> | | Physical Location:<br><b>Point Pleasant Rd</b> | | Federal ID — Plant Code #:<br><b>26-2863376-3</b> | |

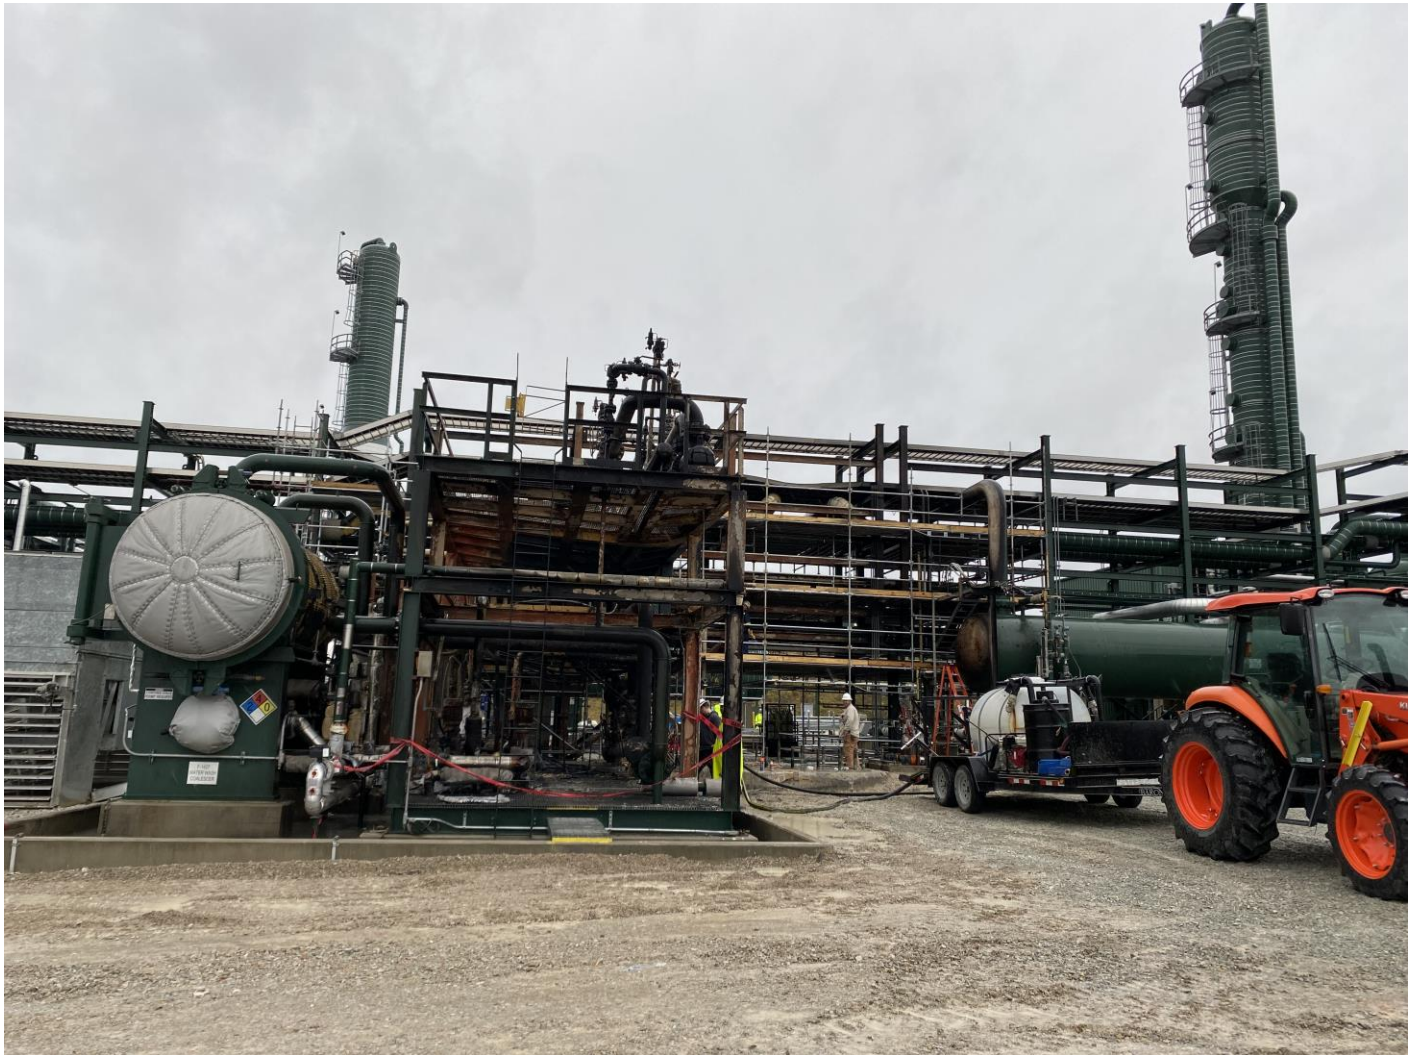
The fire occurred around the “water wash” area, which is otherwise known as part of the amine system. Amine systems operate to remove methanol, H<sub>2</sub>S, and CO<sub>2</sub> from the gas stream. Photo #1 below shows the “water wash” area on 1/3/2023. The contact tower from the amine system (pictured below in photo #2) took much of the damage from the fire.

Photos taken by Anna Hensel on 1/3/2023:  
Photo 1 – Water wash area with damaged equipment

Brad stated that although the cause of the fire is still under investigation, ETC has determined that a leaking valve at the water wash area (1 inch line under 500 lbs pressure) resulted in a vapor cloud of C<sub>2</sub>+ material. The vapor cloud then ignited and the fire spread to surrounding equipment. The ignition source is currently unknown, and there were no known combustion sources in close proximity.

We inquired about the need for replacement equipment. Though the damage to the water wash area appeared to be extensive, other areas of the plant were not impacted. Jason stated the plant flare was inspected and though they have not yet received final determinations, the flare tips and other parts of the flare appear to be in good working order. The cryo tower, heaters, thermal oxidizer, and other plant equipment were not impacted by the fire. Alex noted that replacement of equipment authorized by the current Air Quality permit may require a new authorization to ensure the latest standards are met. Alyssa stated she would send to Alex (with cc to me) a list of equipment that will need replacement for PADEP's permitting considerations.

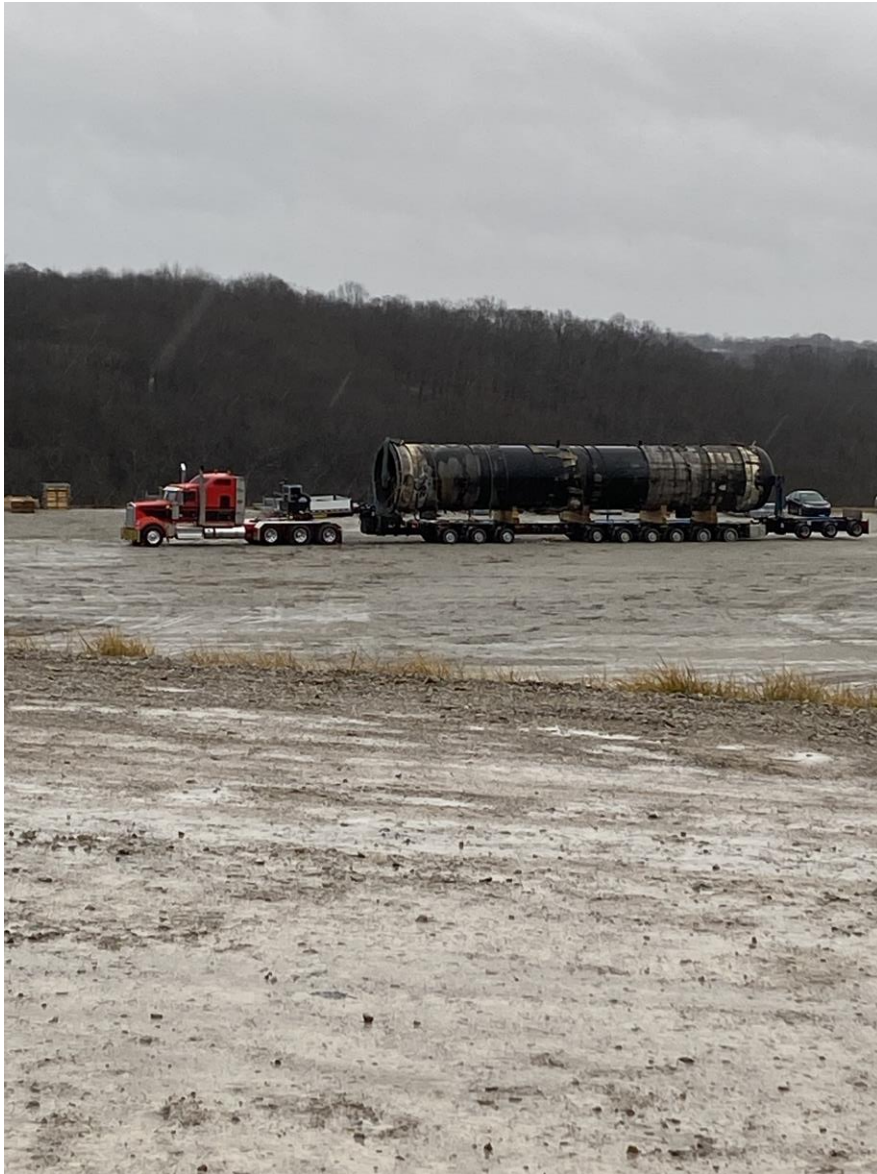
**Photo 2 – amine system contact tower (had been in place on cement pad in photo #1 where person with gray shirt and brown pants in standing)**
